JUPITER PLANTATION DOCK CONDITIONS ASSESSMENT REPORT

Jupiter Plantation Homeowners Association
825 Center Street · Jupiter, FL
September 19, 2023

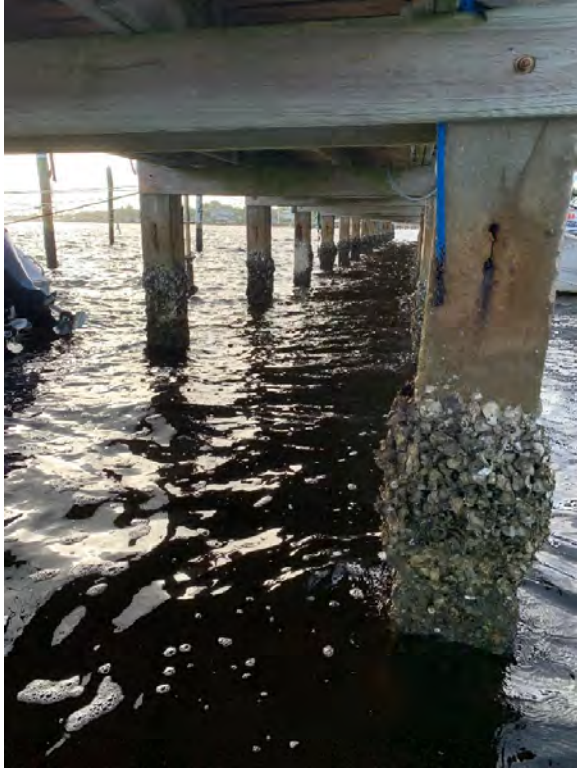
The Jupiter Plantation dock piles are all showing evidence of rust-bleeding and cracking. Approximately one third of the piles have advanced into the stage of significant cracking and spalling. Aside from a select few piles at the northeast corner of the structure, all piles appear to be roughly the same age. Therefore, it is a fact that the piles showing rust-bleeding and early cracking will also continue to deteriorate to the point of spalling.

Rust-bleeding and cracking concrete piles

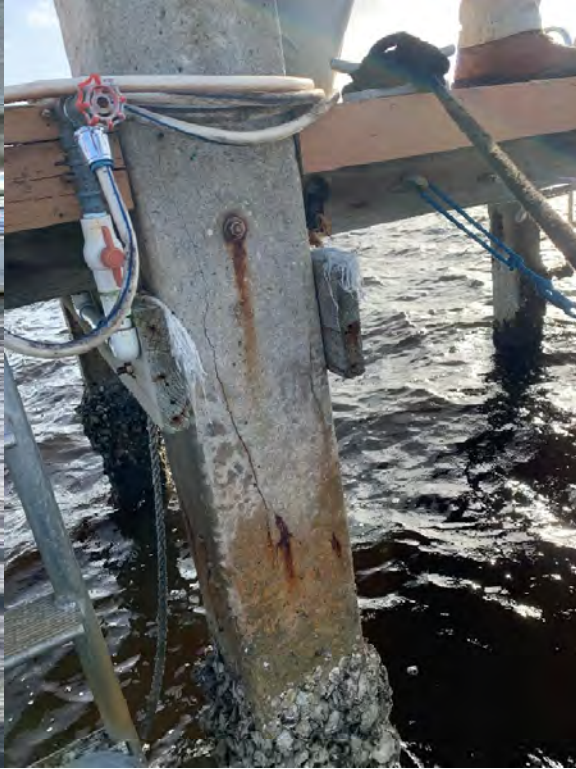
Rust-bleeding and severely cracking pile

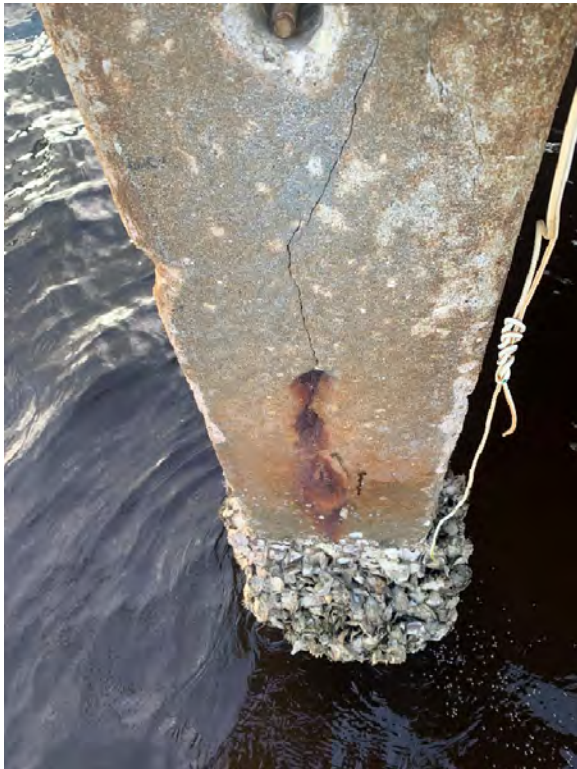
Severely cracking pile

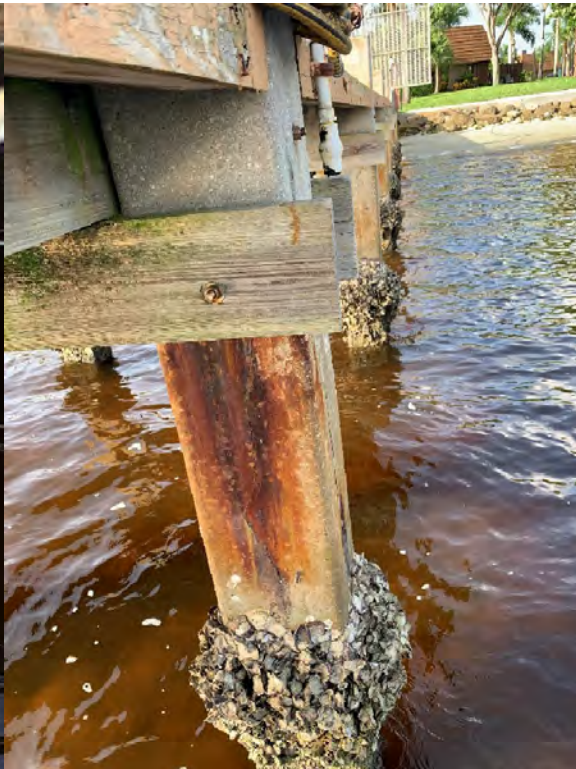
Severely cracking and rust-bleeding pile

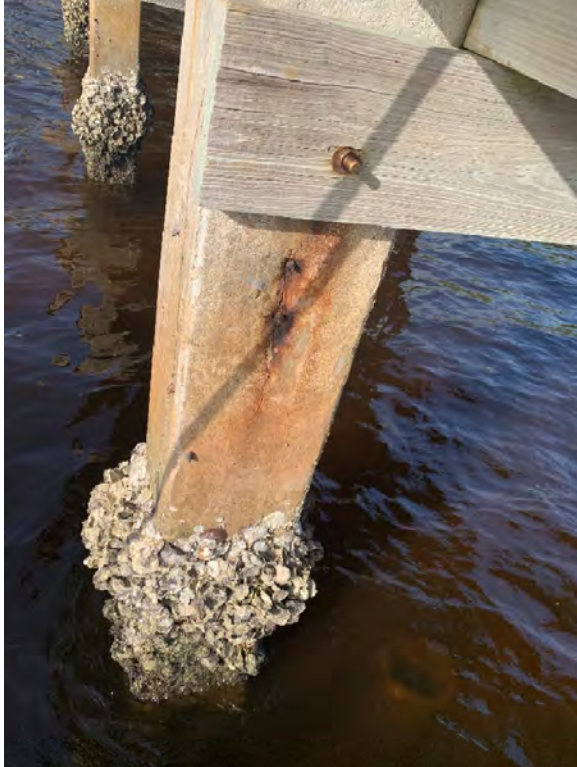
Rust-bleeding and cracked pile

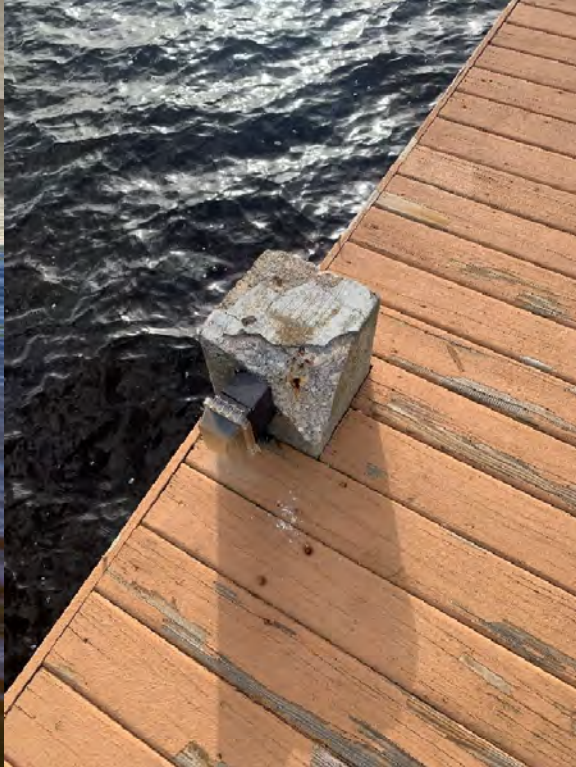
Spalling pile previously repaired

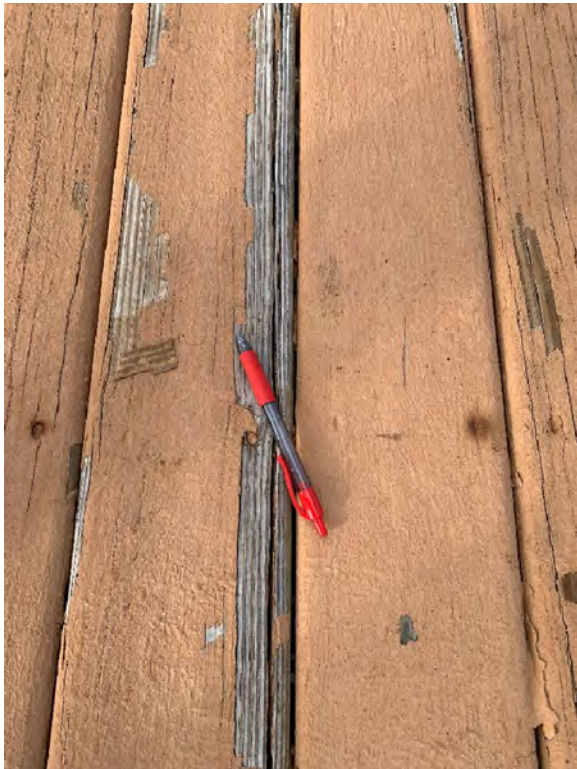
The existing decking is in poor condition. Much of the decking is badly splitting and splintering. At some point, the decking was painted, which has helped to extend the life, but many deckboards have lost structural integrity due to dry rot over the years. Connection hardware is severely corroded and degraded.

Dry-rotting, splintering and splitting deckboards

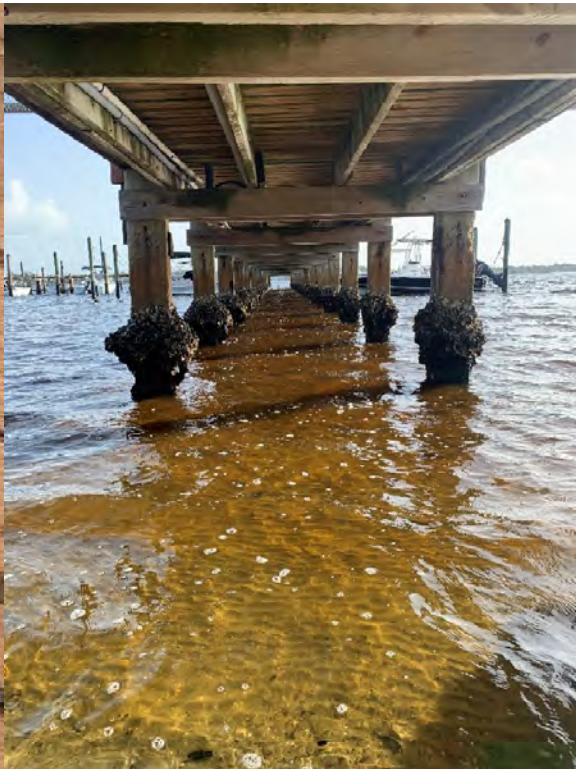
Cracked piles, framing showing signs of splitting, mildewing

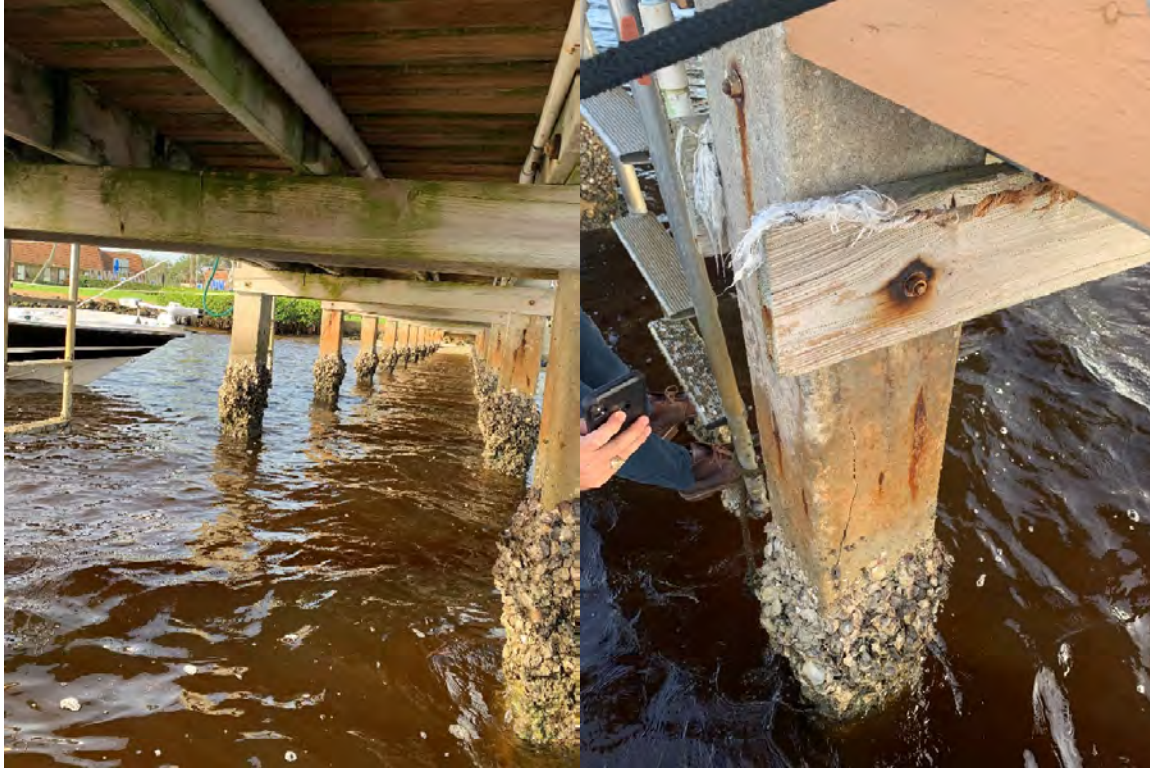
The existing timber framing is in poor to fair condition. Pile caps and stringers have experienced dry rot due to constant exposure to the elements. The rot has resulted in isolated loss of structural capacity, with well over half of the framing members exhibiting some deterioration. Some of the hardware has been replaced over the years, but many of the nuts and bolts are experiencing corrosion due to saltwater inundation.

Splitting framing members, mildewing wood Cracked pile, rotting pile cap framing

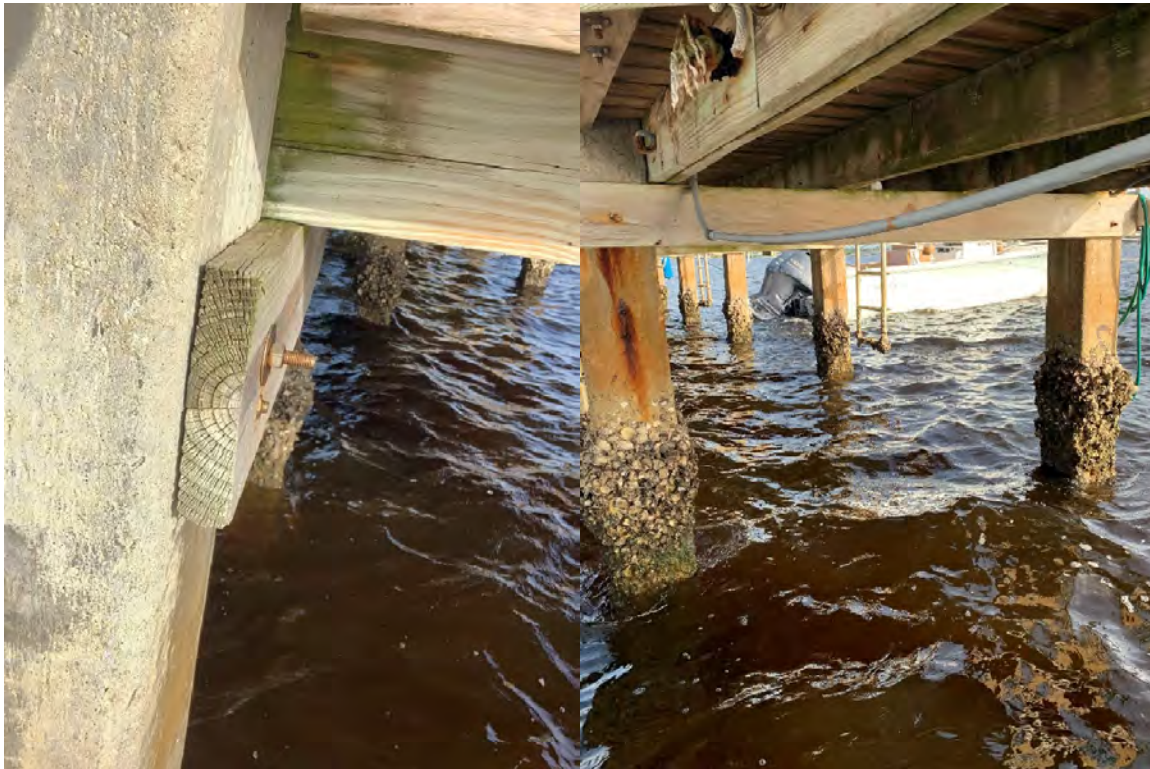
Newer hardware, splitting stringer Electrical conduit, hanging, no hanger straps
