## JUPITER PLANTATION SHORELINE CONDITIONS ASSESSMENT REPORT

Jupiter Plantation Homeowners Association  
825 Center Street · Jupiter, FL  
September 29, 2023

### **Shoreline Conditions Assessment Report**

825 Center Street, Jupiter, FL  
September 29, 2023

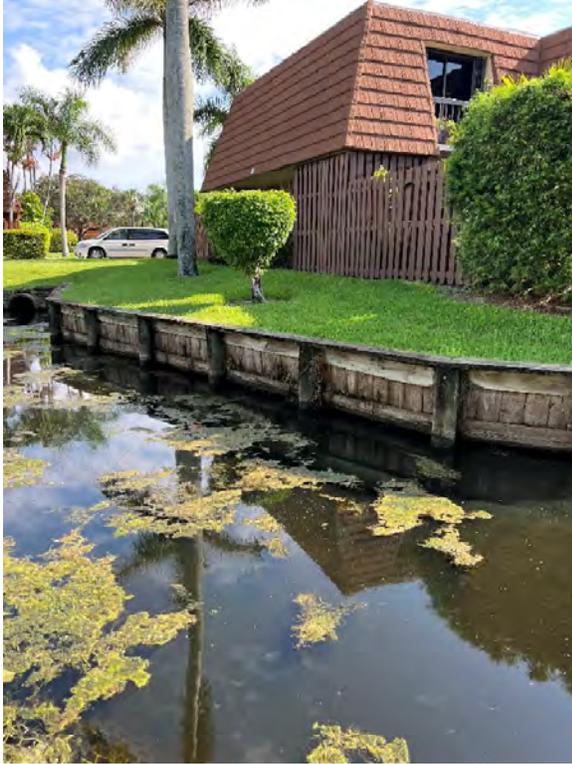
The walers, sheetpiles, and top cap are in poor to fair condition, in an advanced stage of deterioration. These structural components are rotting from constant wetting and drying cycles, resulting in splitting and failing members.

*Timber bulkhead, dry-rotted walers and sheetpiles*

- **Years 3 to 5:** replace timber bulkheads with vinyl sheetpile and concrete cap system

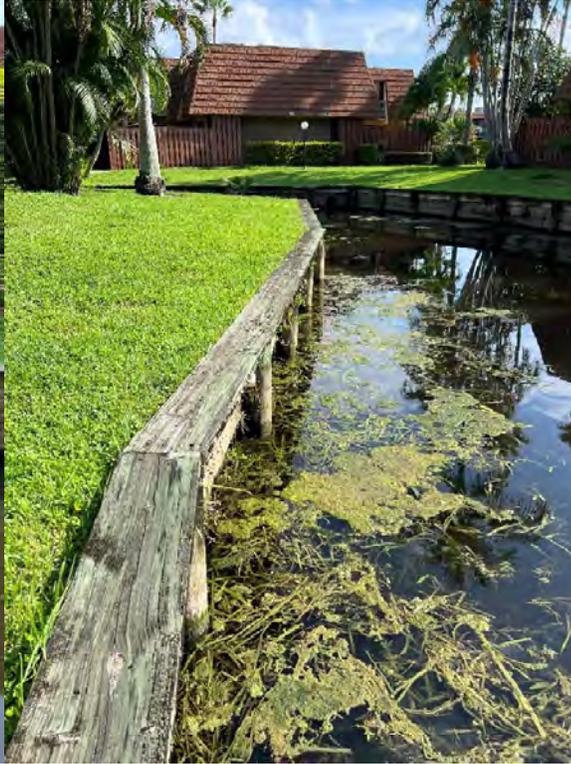
*Timber bulkhead, dry-rotted walers and sheetpiles*

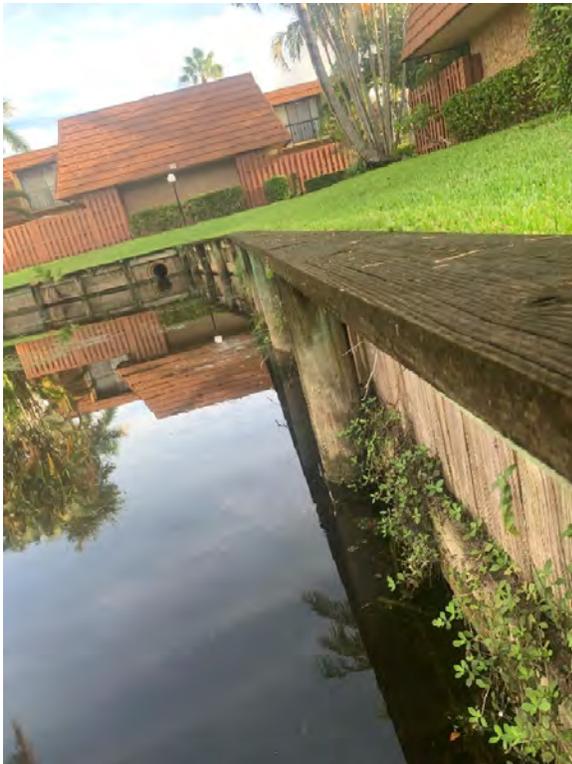
*Timber bulkhead, vegetation protruding through timber sheeting*

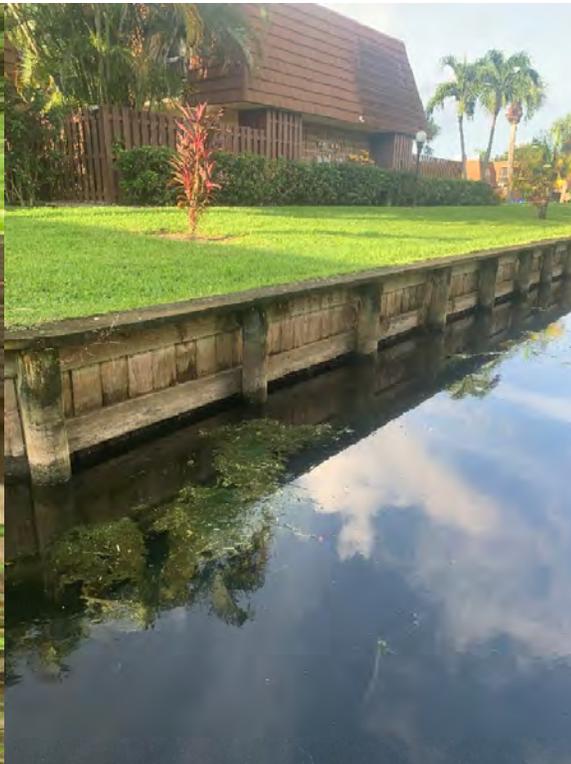
*Timber bulkhead, deteriorating walers and sheetpiles*

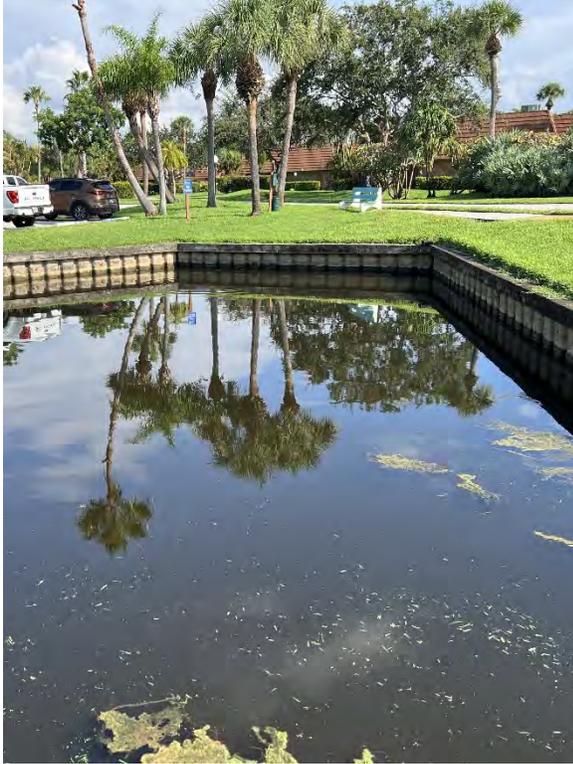
Overall, this section of wall is in fair to good condition. There were some isolated cracks detected in the sheeting but overall the sheeting is fully intact and the concrete cap is straight with no obvious movement or rotation. These conditions would imply that this wall style is still structurally viable.

*Corrugated cementitious sheeting bulkhead  
in fair to good condition*

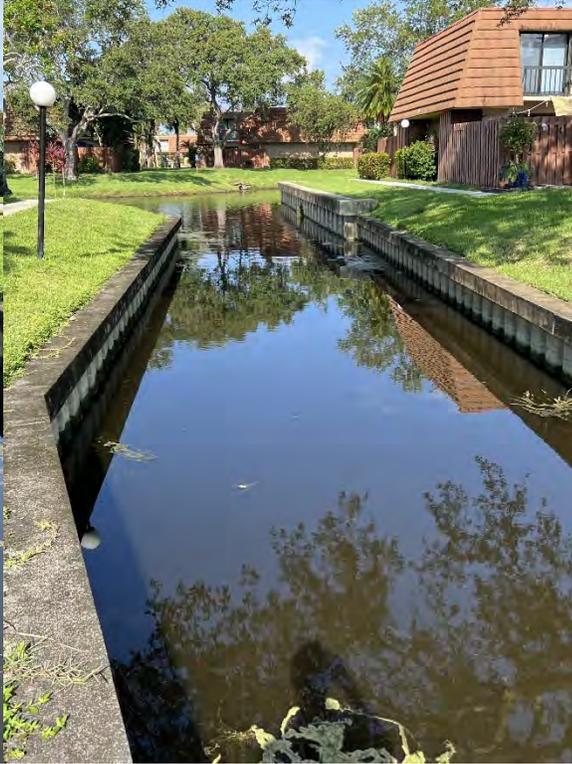
*Corrugated cementitious sheeting bulkhead  
in fair to good condition*

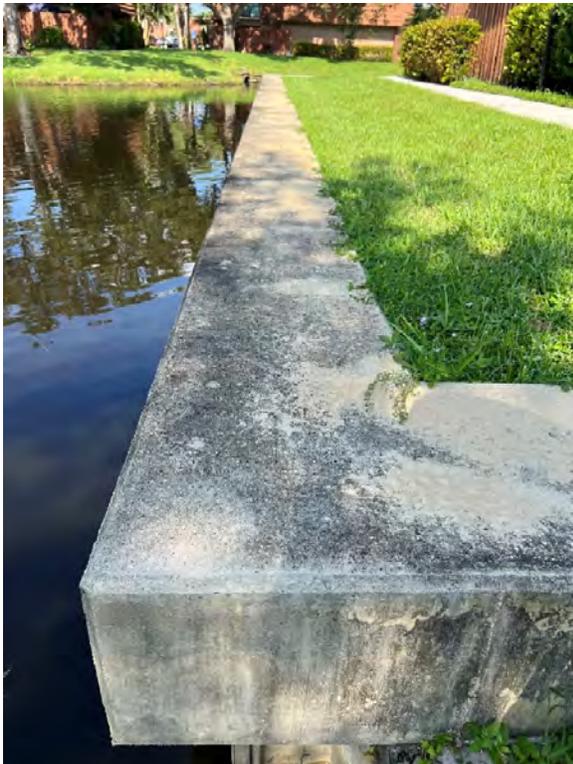
*Newer vinyl bulkhead, in good condition*

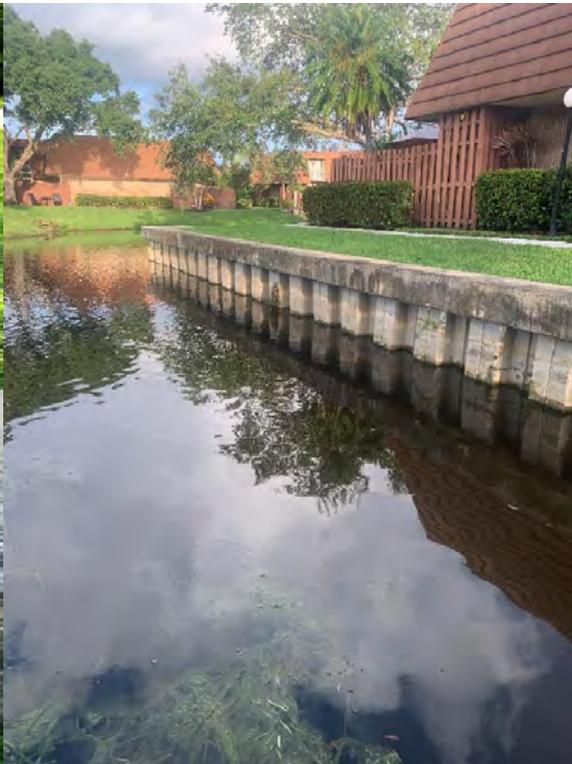
*Corrugated vinyl sheeting, in good condition*

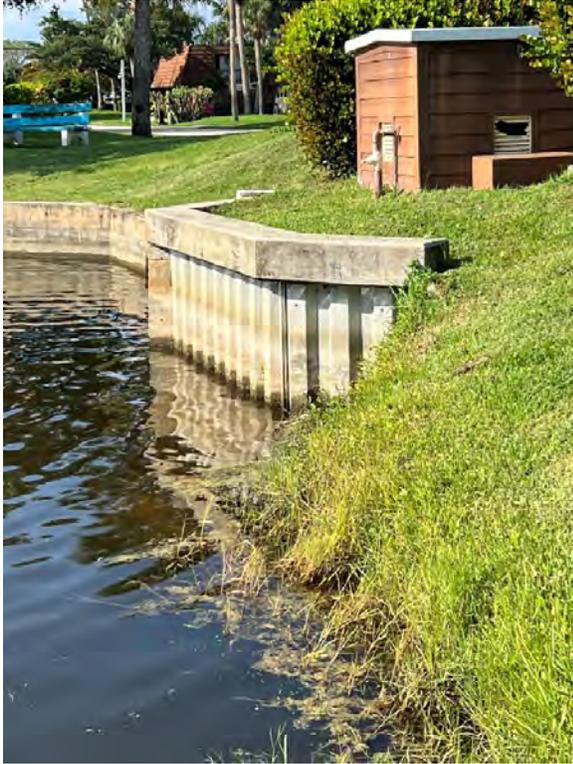
*Aluminum headwall in good condition*

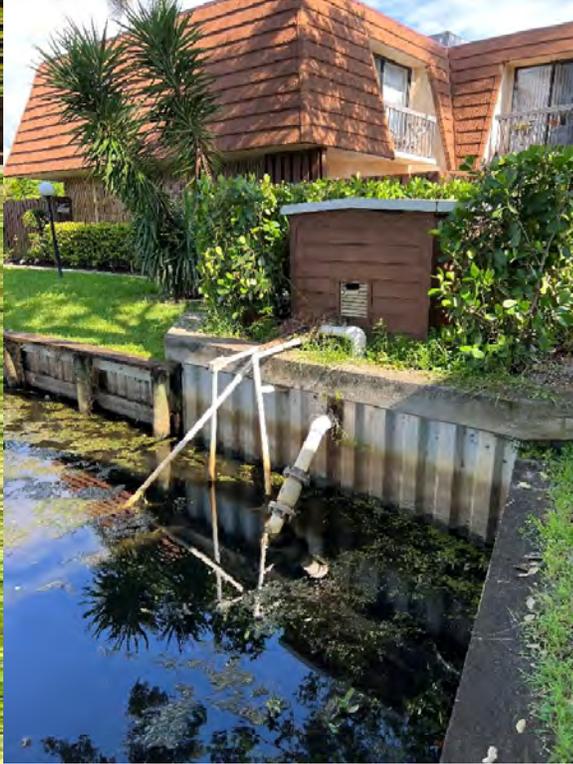
*Aluminum headwall in good condition  
some backfill loss through pipe penetrations*

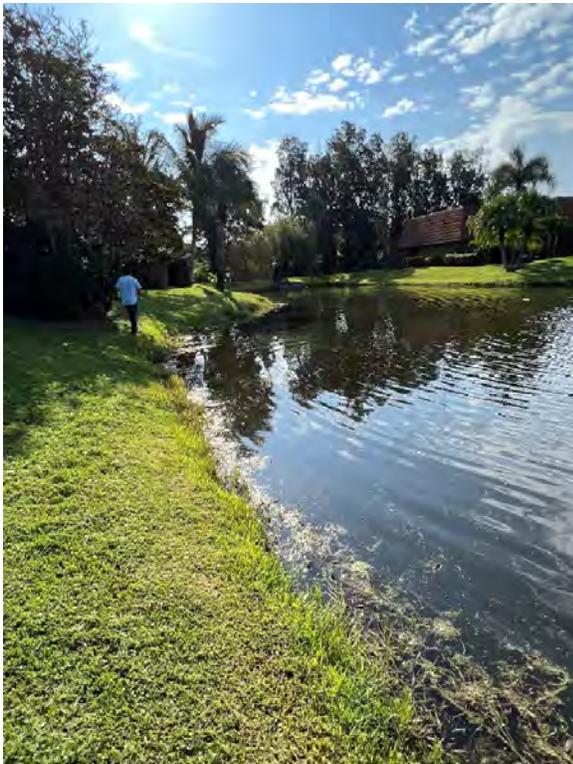
In general, the grassed shorelines along the lakes are in fair to good condition. Over time, the embankments have experienced settlement due to basic long-term soil compaction, stormwater runoff, irrigation, and rainfall. Some areas of settlement are more notable than others; in these areas, the slopes and tops of banks have settled, thereby migrating towards adjacent structures.

*Natural shoreline, grassed embankment  
settling slightly, slopes flattening*

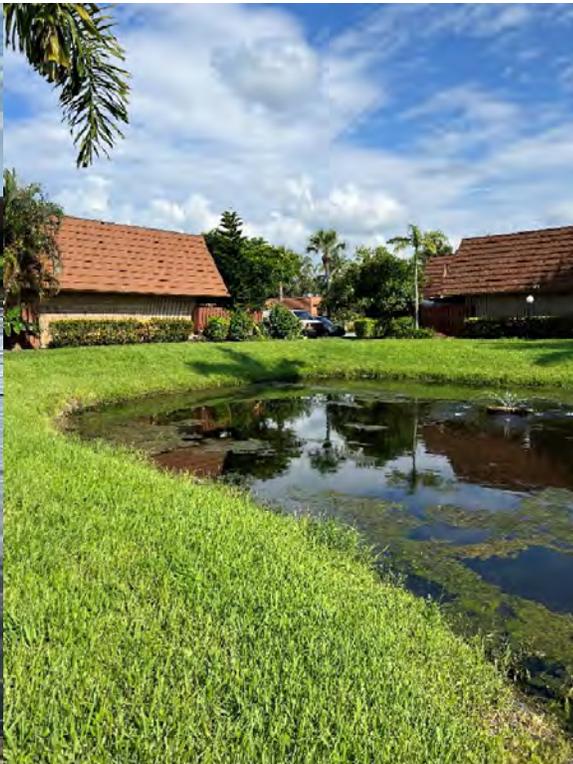
*Natural shoreline, in good condition*

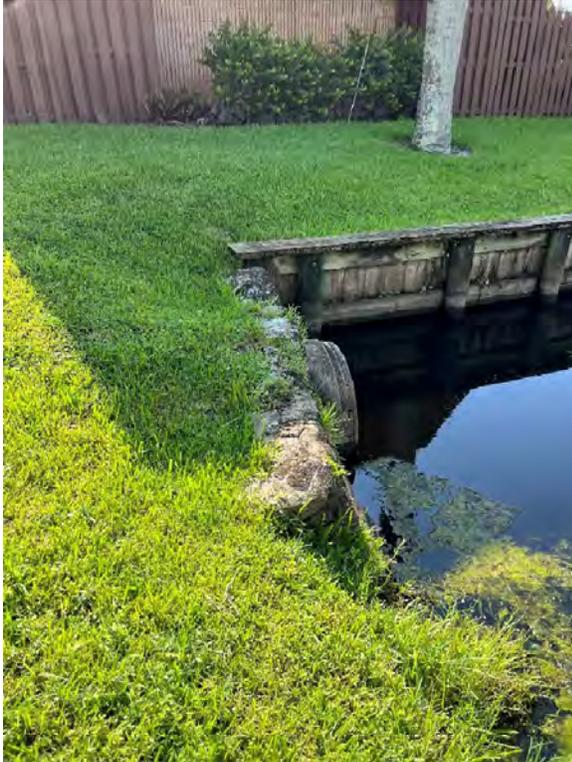
There are several locations along the lake shorelines where concrete bags have been stacked in order to form headwalls around drainage outfall pipes. These areas are experiencing settlement and erosion around the bagged headwalls and should be repaired.

*Timber bulkhead transition to concrete bag headwall; poor condition, bank eroding*

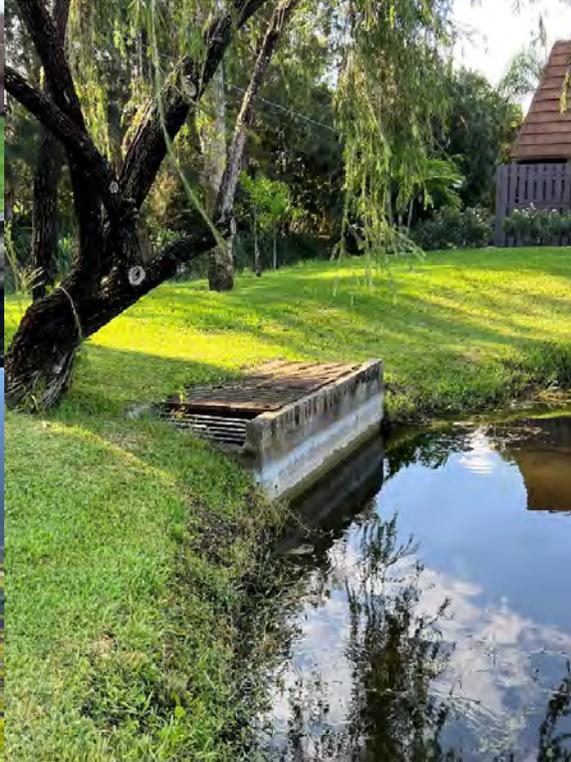
*Natural shoreline with drainage box, some erosion along sides*

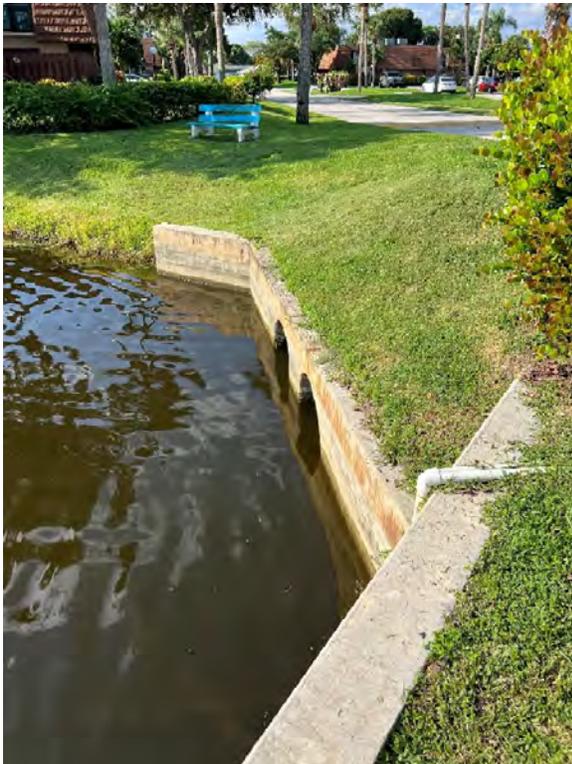
*Concrete headwall in good condition*

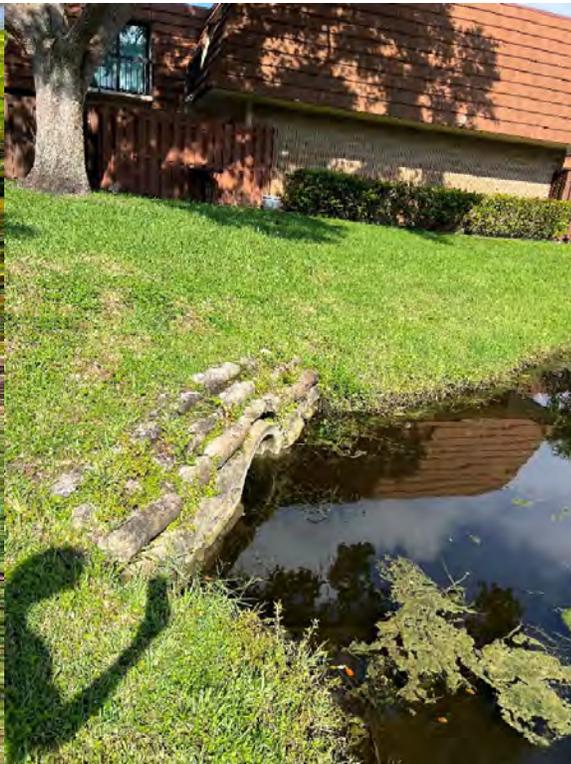
*Concrete bag headwall, bags sagging and settling*

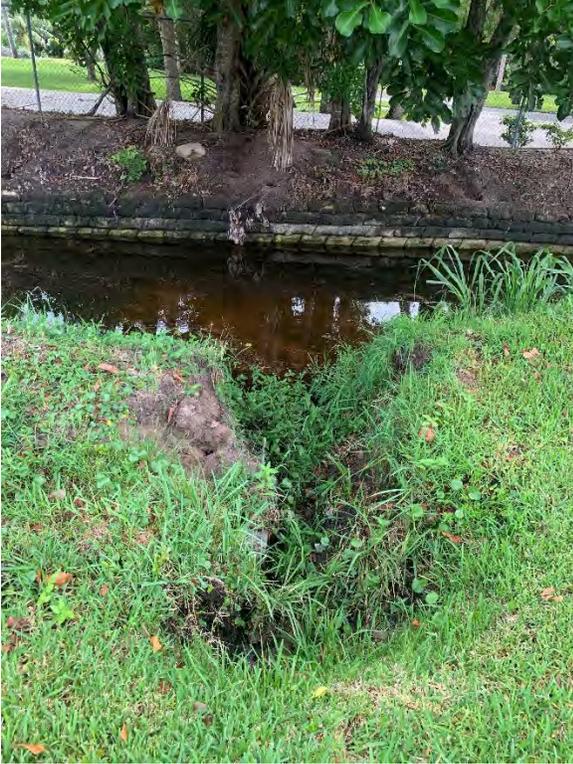
The east drainage canal embankments are in fair condition. On the west side of the canal (Jupiter Plantation side) the slopes are experiencing some settlement due to stormwater runoff and heavy rainfall events. There are several concrete drainage flumes along the eastern canal that carry stormwater from the small parking areas down into the drainage canal. In three locations, these flumes have been undermined to the point where the parking lot asphalt has failed and the flumes have been undermined.

*Drainage canal, eroding bank from stormwater runoff*

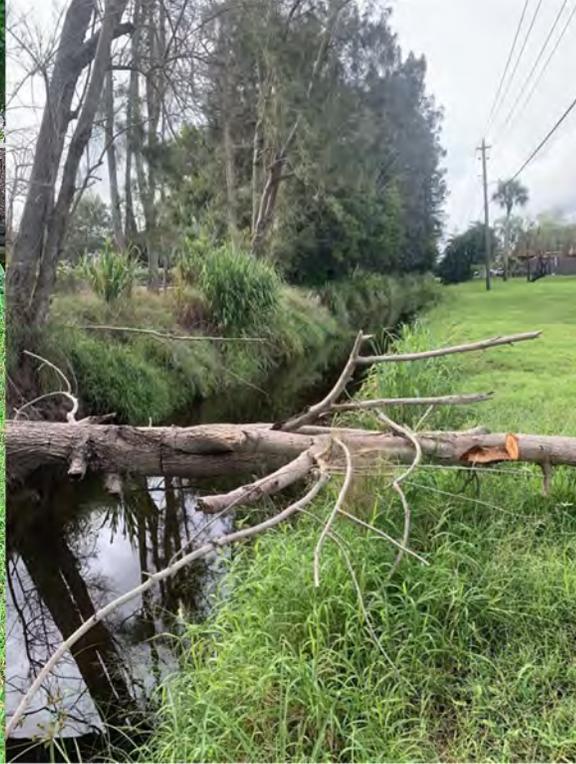
The east side of the canal is at a steeper slope and is experiencing more severe erosion. Of particular concern are the large trees along the bank that are in danger of falling (some already have fallen across the canal). These trees present a potential hazard to Jupiter Planation property as well as to the effectiveness of water flow through the canal during storm events.

*Drainage canal, fallen pine from east side; eroding bank and multiple leaning trees*

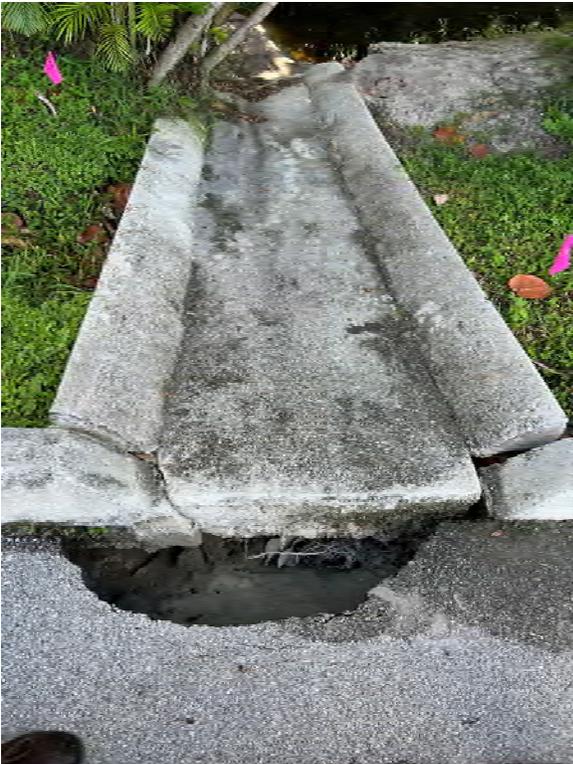
*Undermined concrete flume at east canal, failed asphalt*

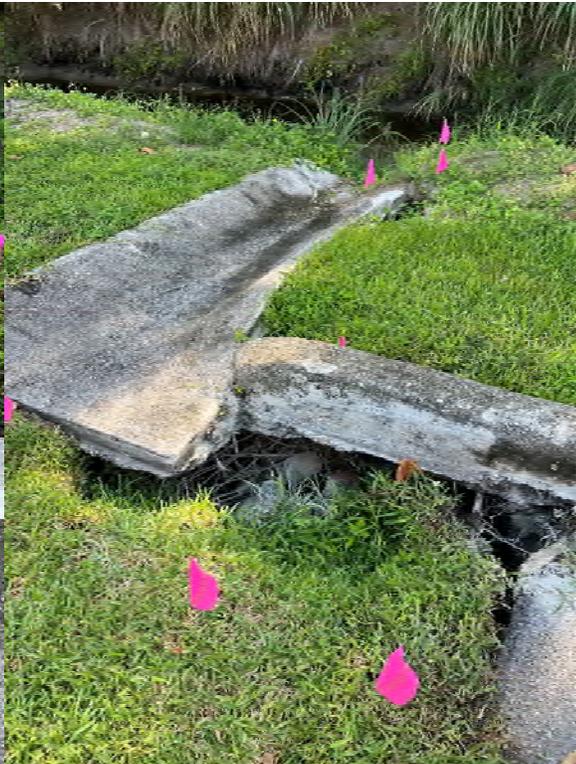
*Undermined concrete drainage flume at east canal (one of three)*
